# Navajo Abandoned Uranium Mine

## Site Screen Report

## Sandy K AUM Site

August 2010

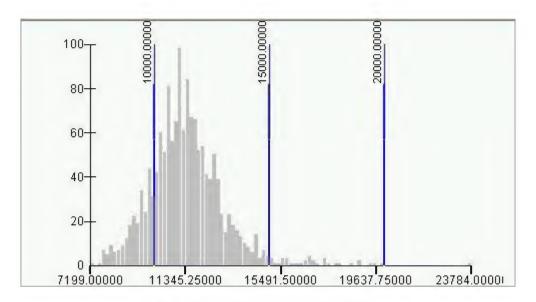
The following chart and statistics were generated by ESRI ArcGIS 9.3.1, and show the general distribution of the site gamma radiation measurements. The horizontal X axis represents the gamma radiation reading levels in cpm (lowest levels to the left). The vertical Y axis represents the frequency of each gamma radiation level.

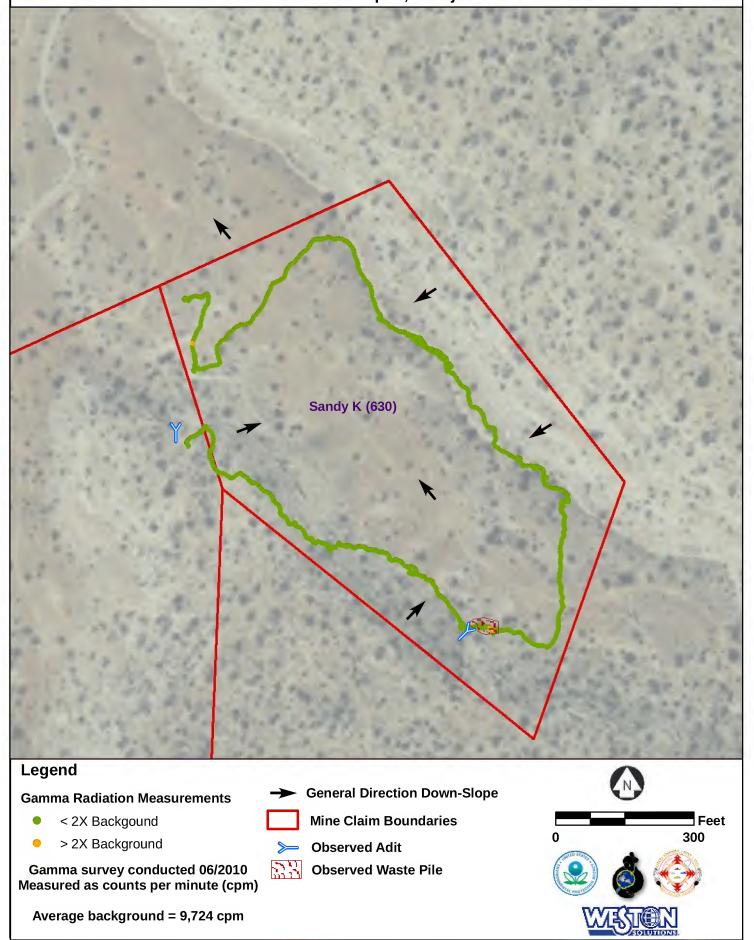
Figure 1 - Gamma Radiation Measurements, Above Two Times Background
Sandy K (630)
Teec Nos Pos Chapter, Navajo Nation

A total of 1,452 gamma radiation measurements were collected from the mine site, ranging from 7,199 cpm to 23,784 cpm. Measurements collected in the vicinity of the waste debris were found at levels up to approximately 25,000 cpm. The measurements are represented in Figures 1 and 2.
